A REPORT ON NONDESTRUCTIVE TESTING AND STRUCTURAL ANALYSIS ON ELEVEN IRON CASEMATE CARRIAGES AND CHASSIS

FORT SUMTER NATIONAL MONUMENT

April 2, 1979

LEE WAN and ASSOCIATES, INC.
engineers / architects / surveyors

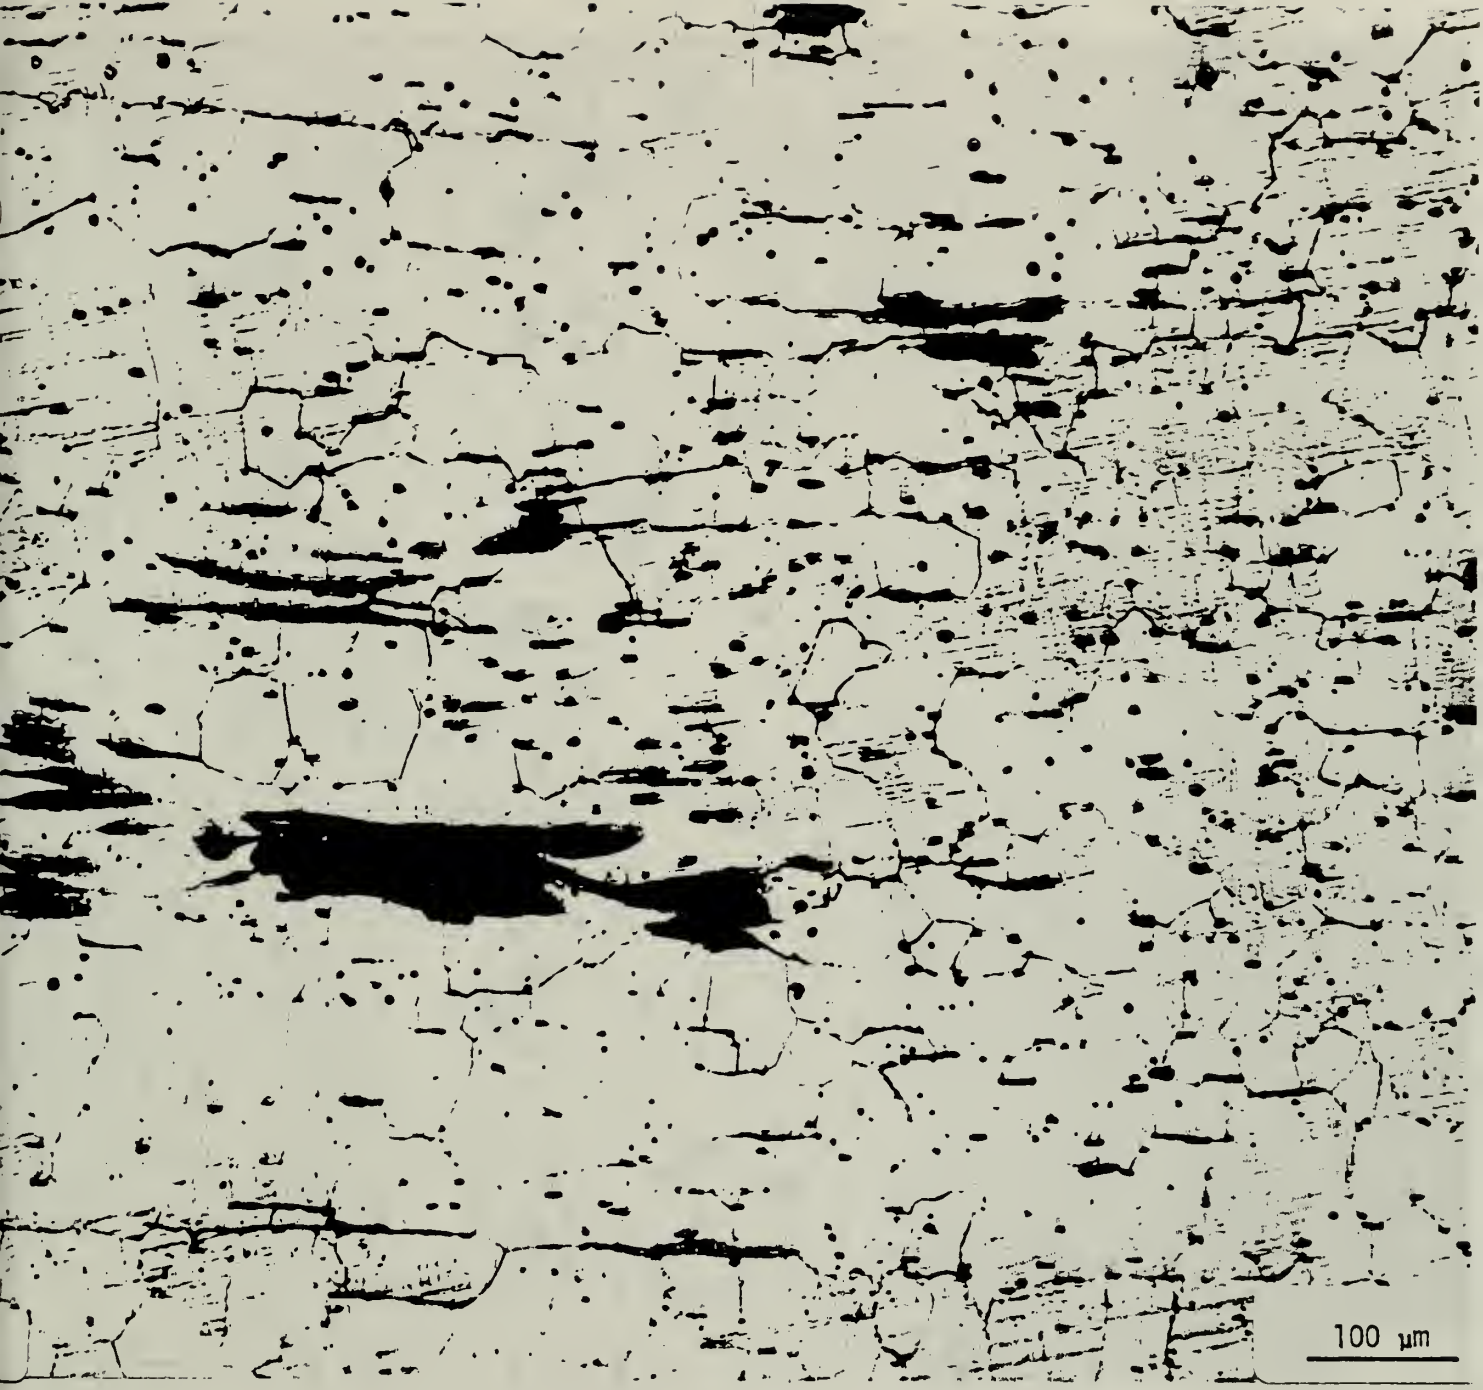
Figure 1a. Optical Micrograph
of Right Face Plate (Piece A)

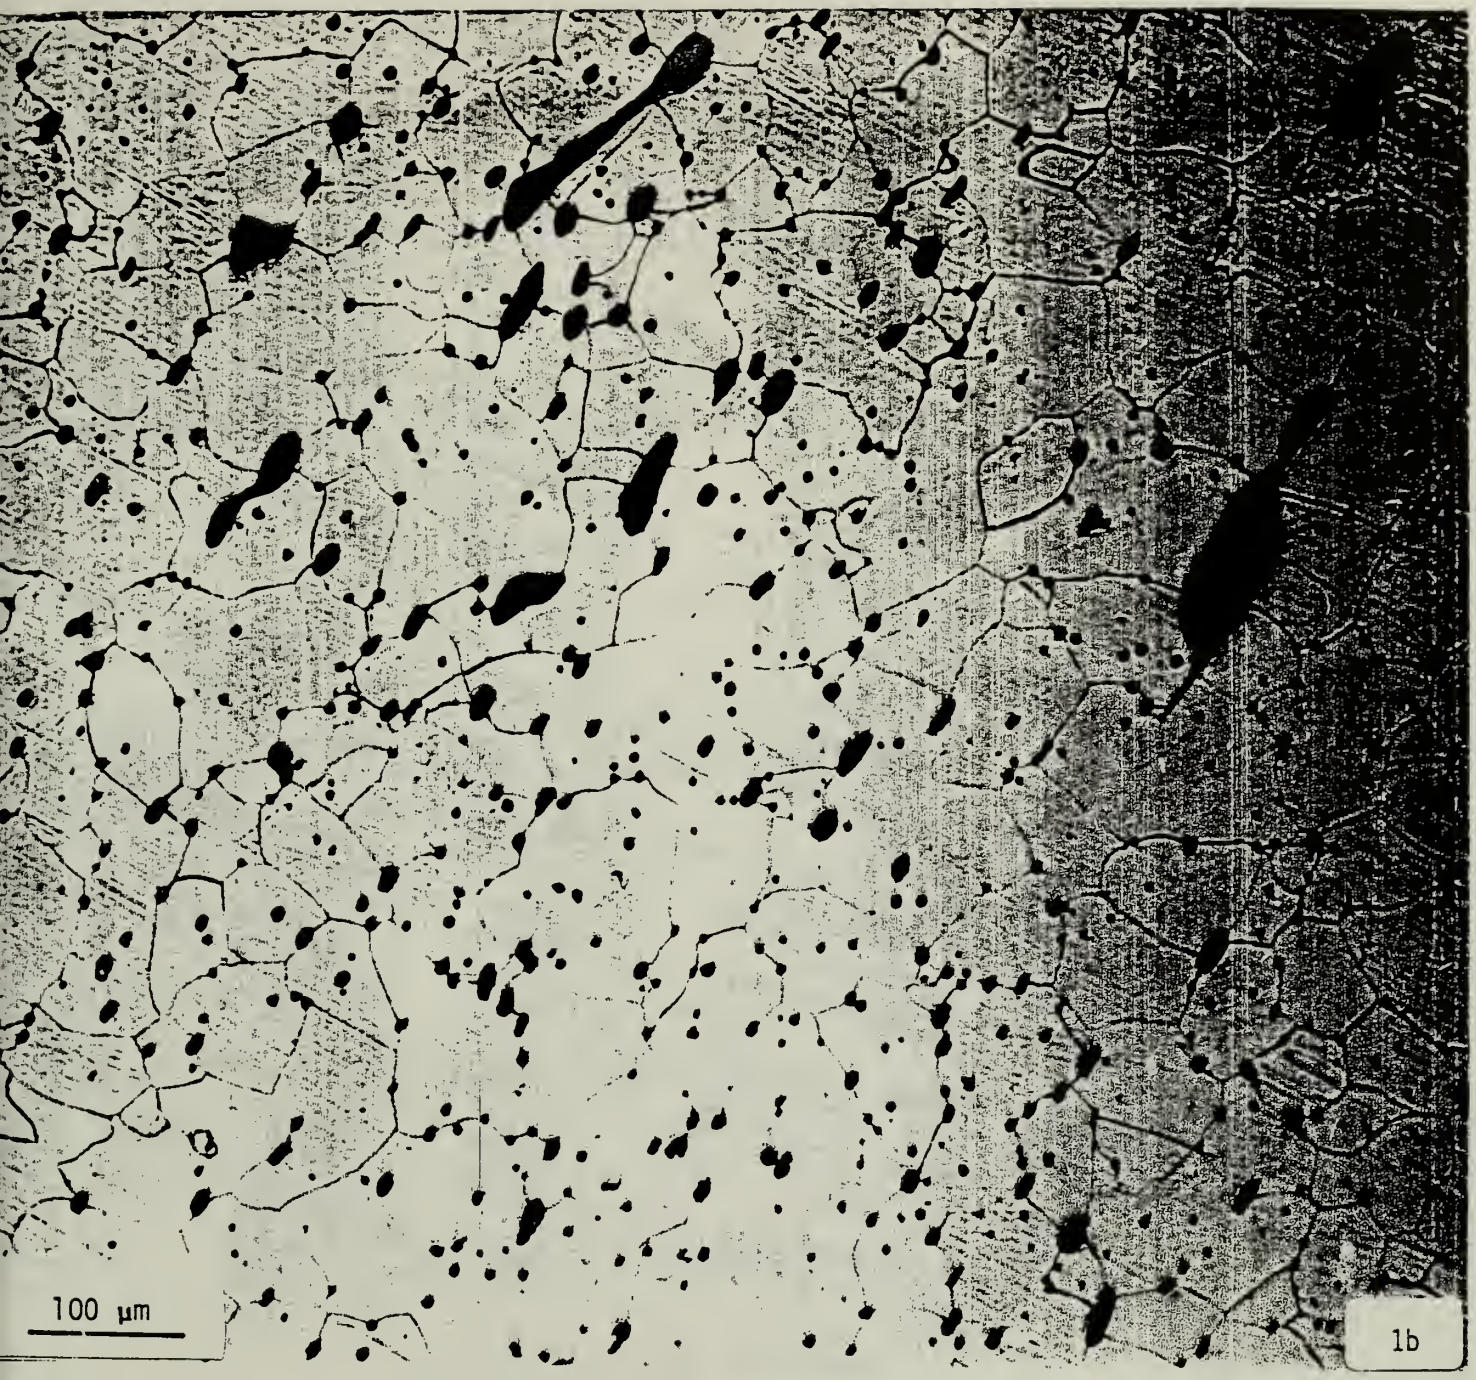
Figure 1b. Optical Micrograph
of Rail (Piece B)

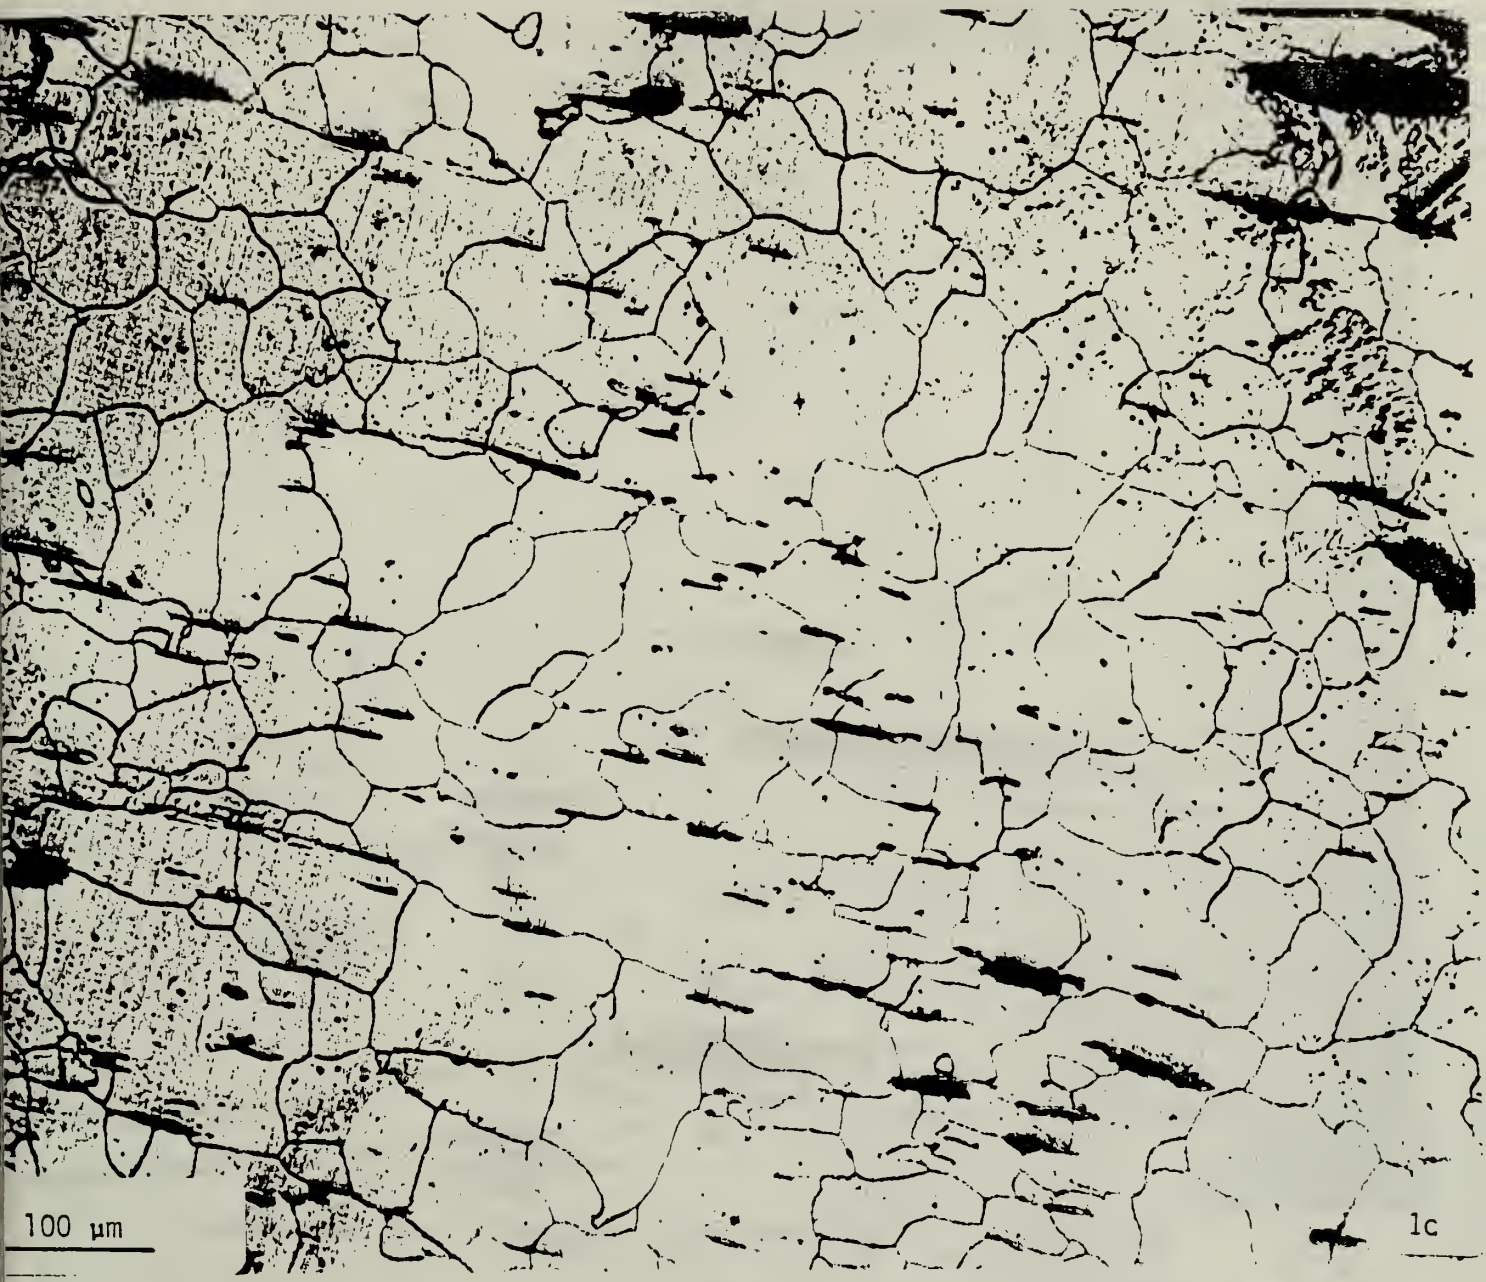
Figure 1c. Optical Micrograph
of Rail (Piece C)

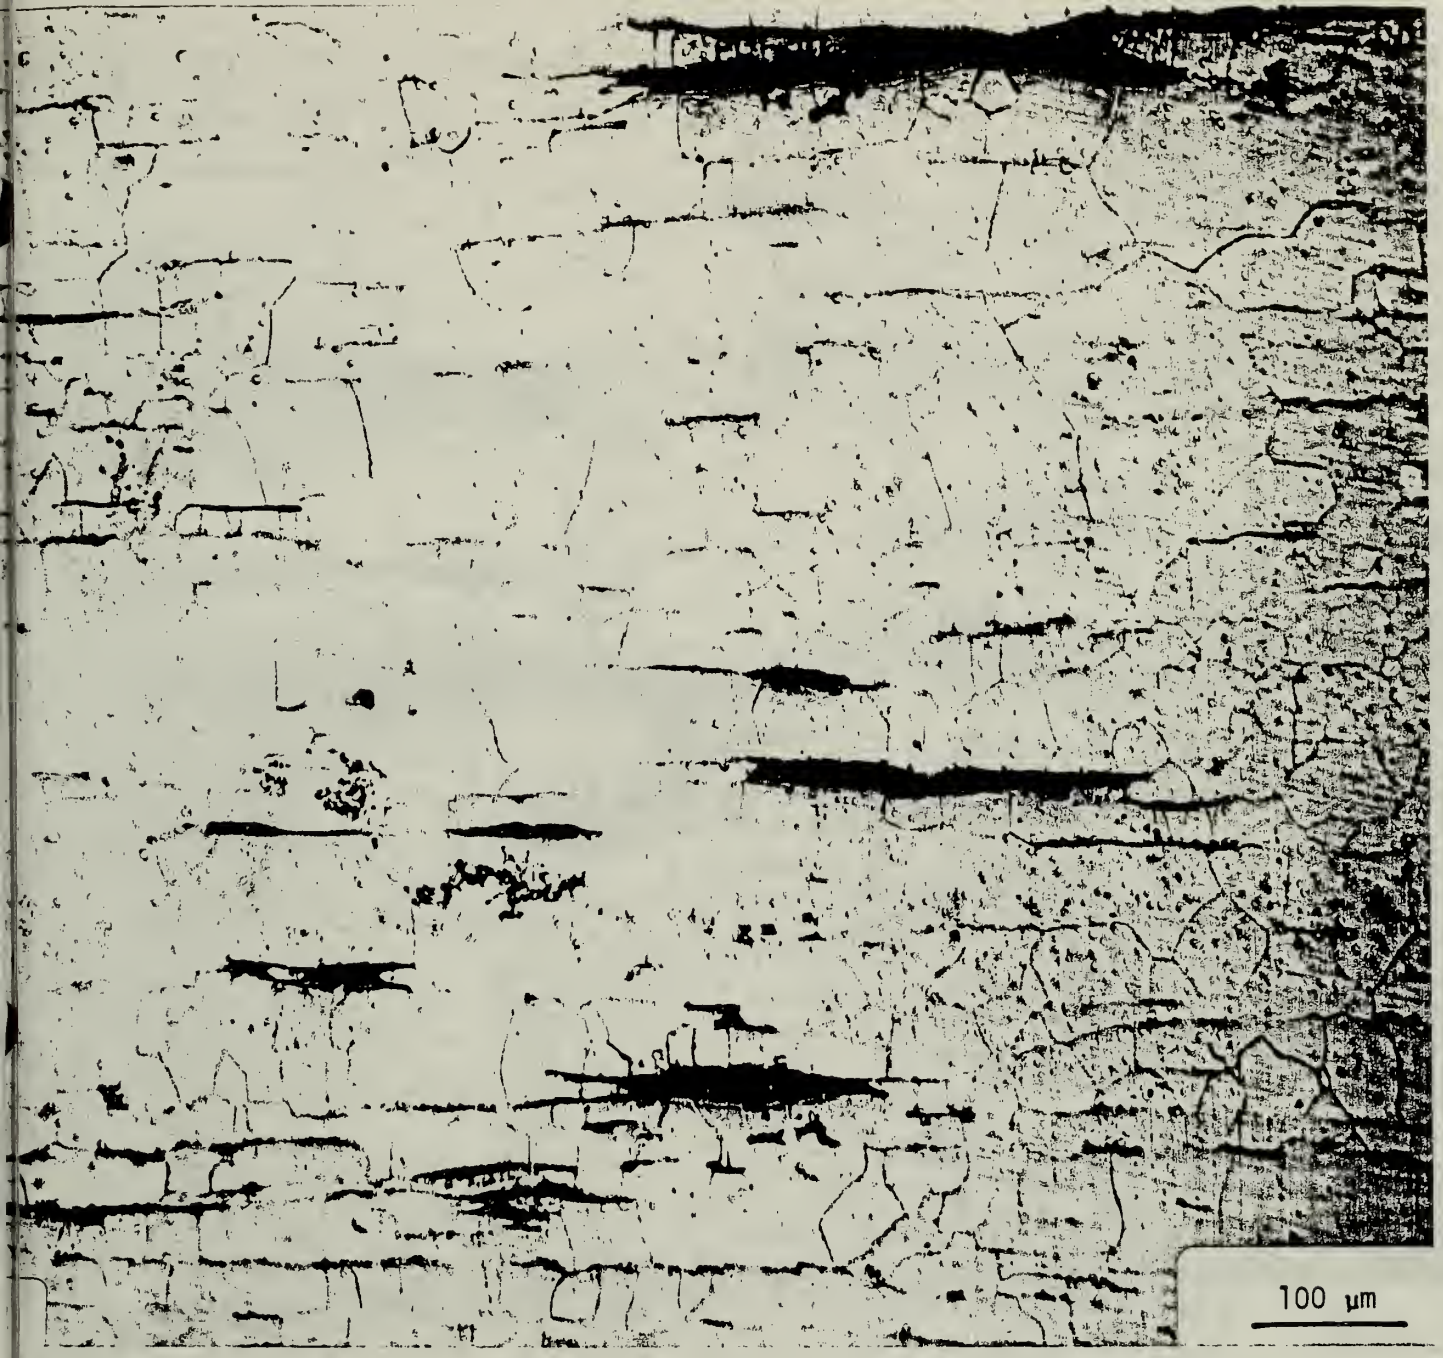
Figure 1d. Optical Micrograph
of Left Face Plate (Piece D)

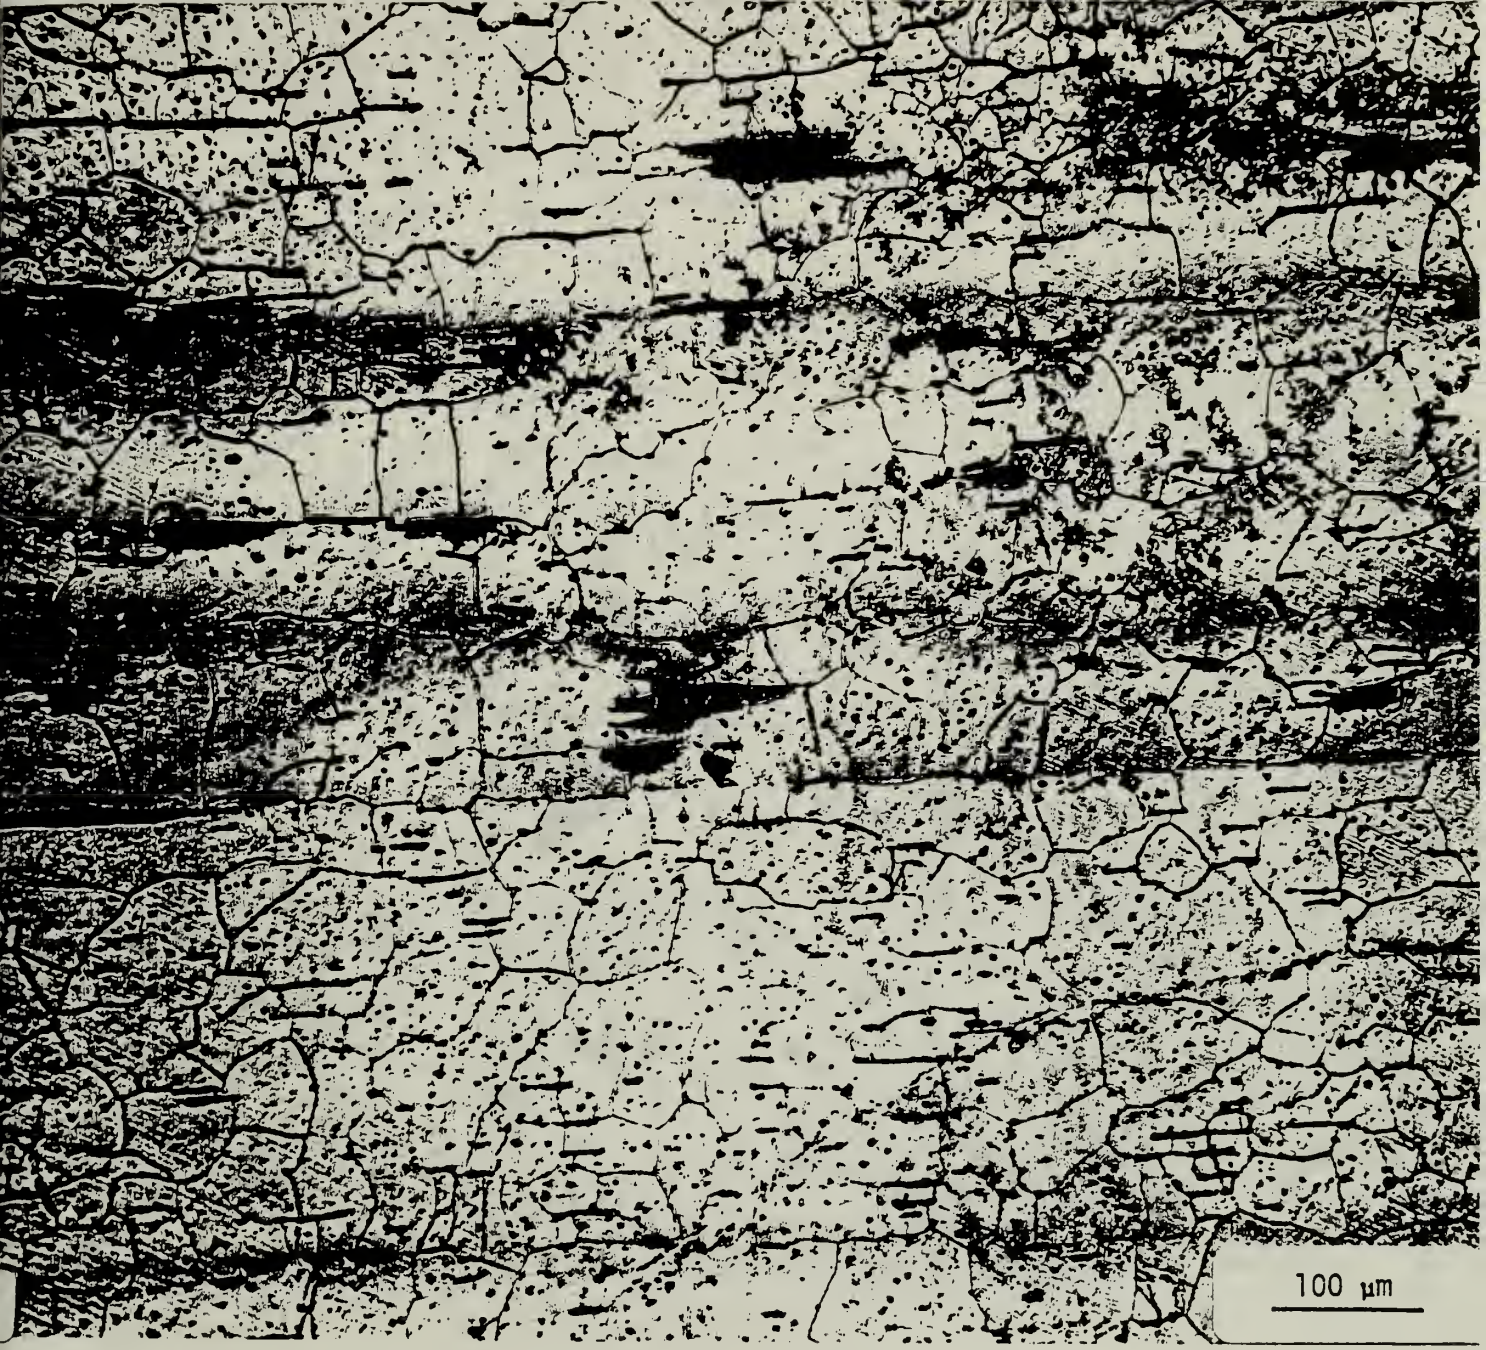
Figure 1e. Optical Micrograph
of Right Face-Rusty (Piece E)

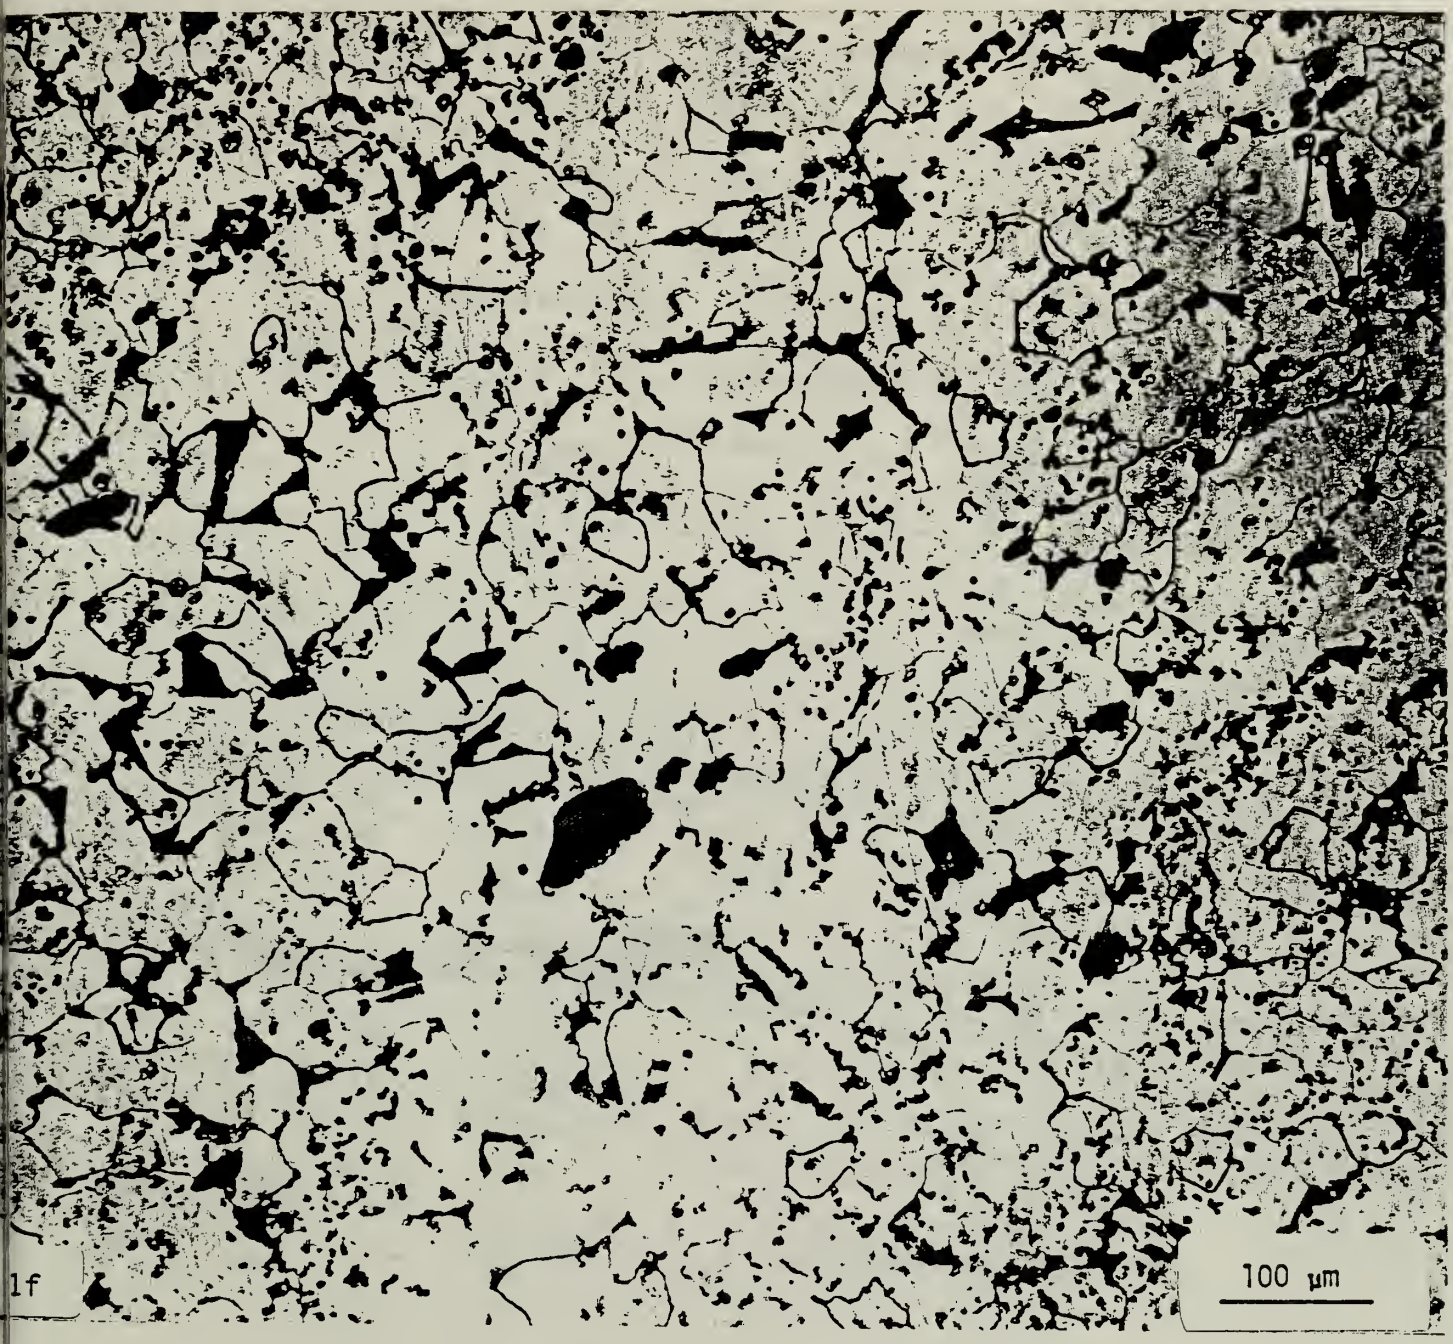
Figure 1f. Optical Micrograph
of Rail-Rusty (Piece F)

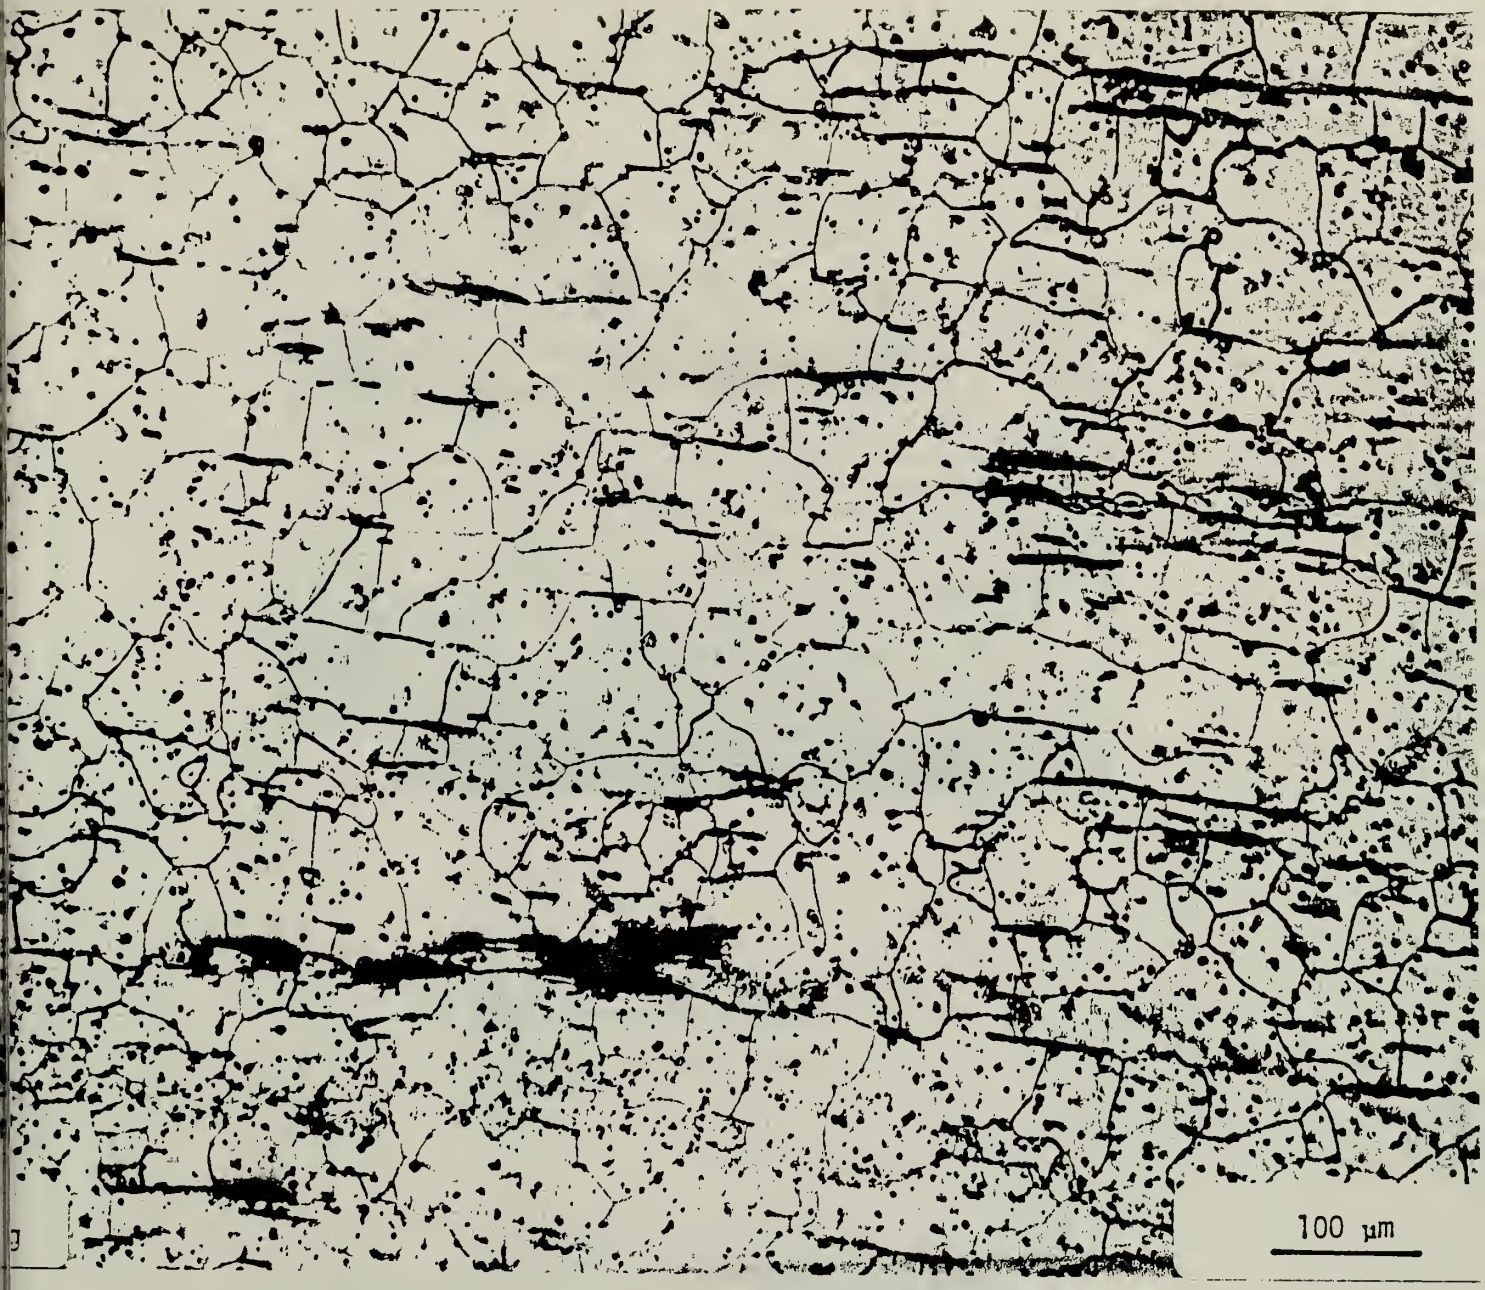
Figure 1g. Optical Micrograph
of Left Face-Rusty (Piece G)

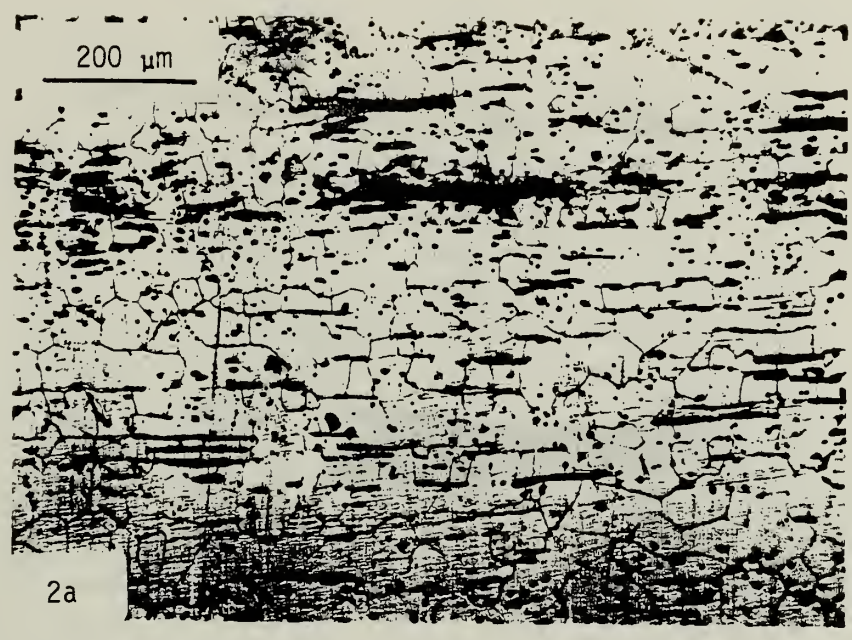
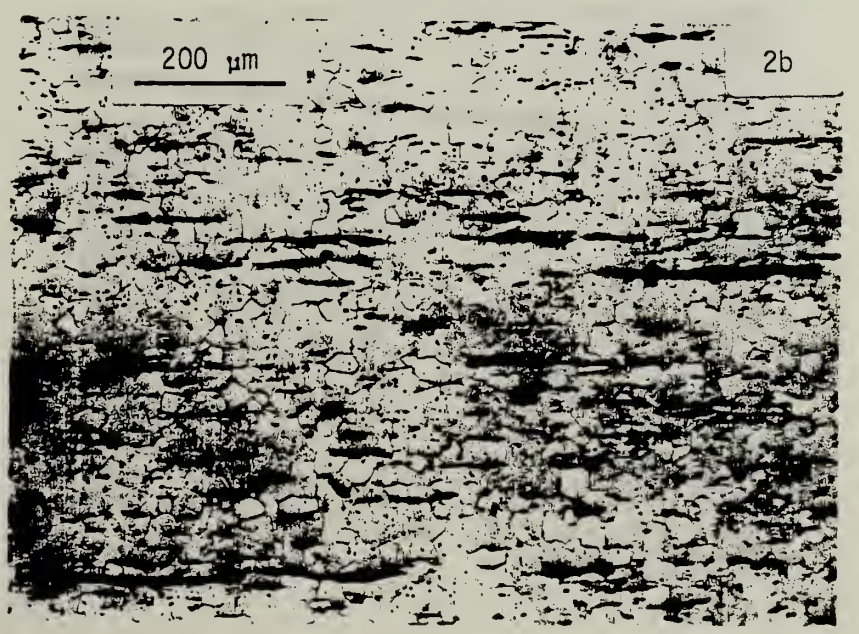
Figure 2. Optical Micrograph of
(a) Right Face Plate (Piece A)
(b) "Modern" Wrought Iron
(Piece H)

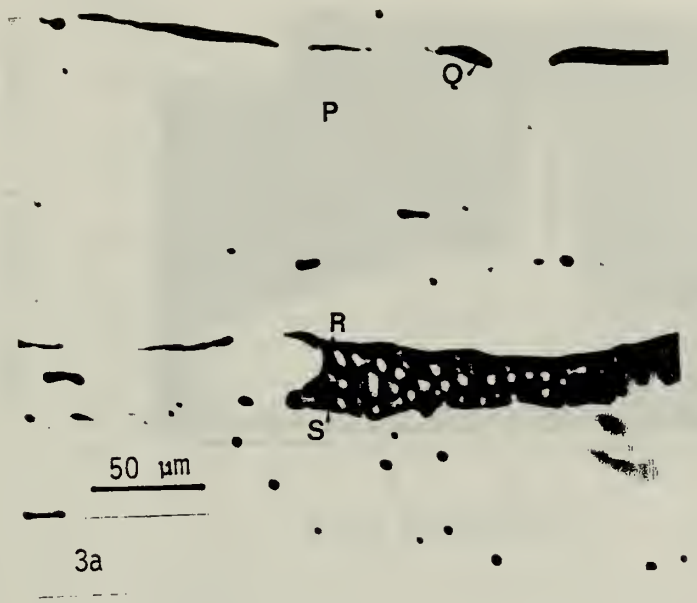
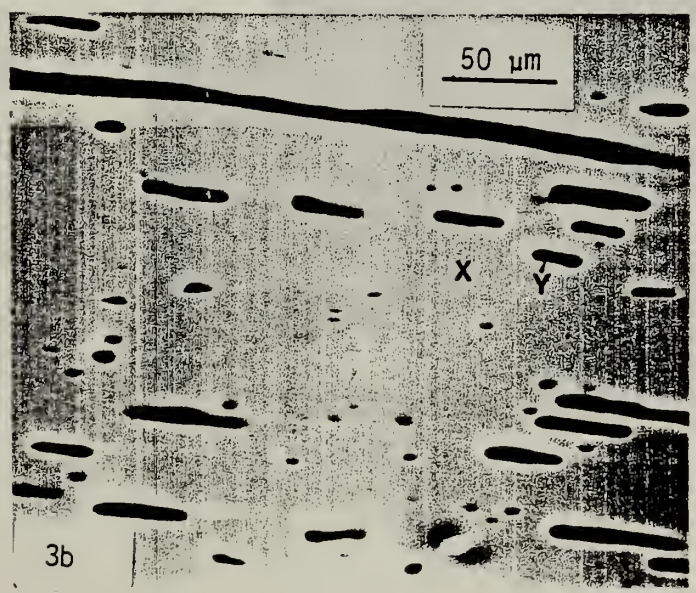
Figure 3. Compositional Back-scattered Electron Image
(a) Piece A

(b) Piece B

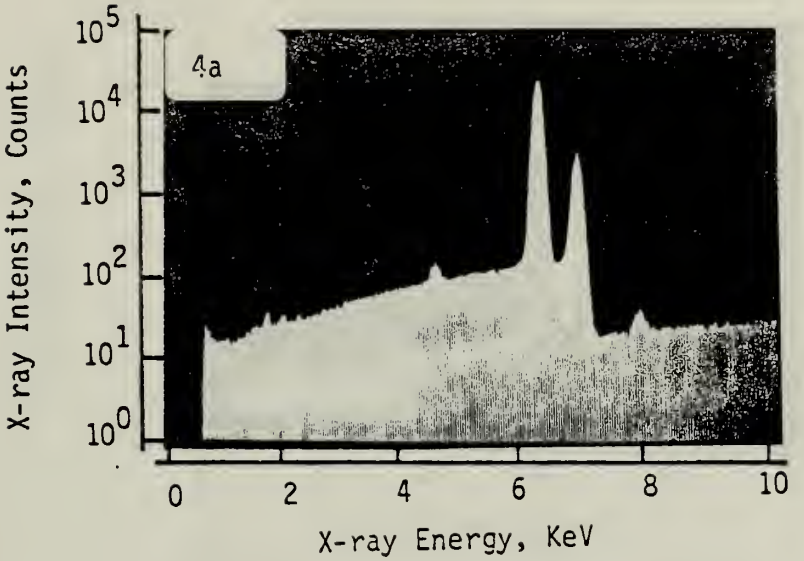
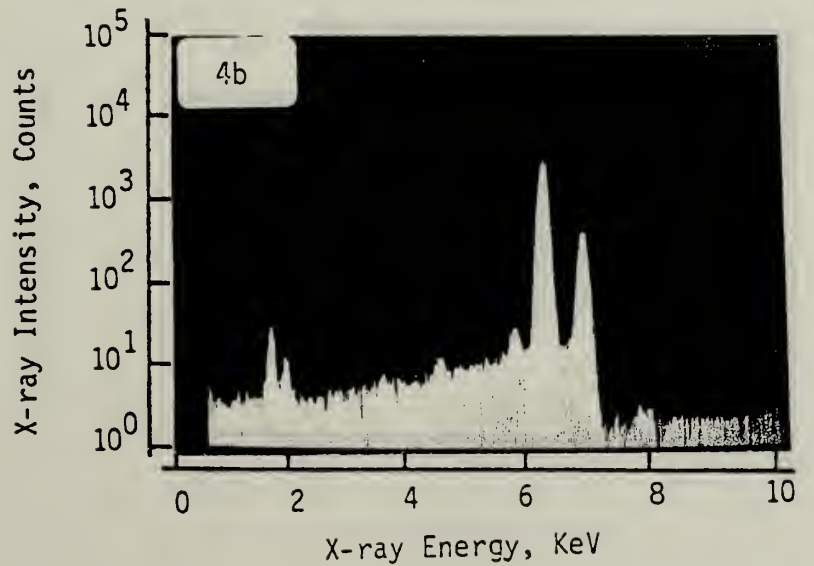
Figure 4a&b. XES Microanalysis Spectra from Piece A (Please see Figure 3a)
(a) Matrix (At point P)
(b) Slag (At point Q)

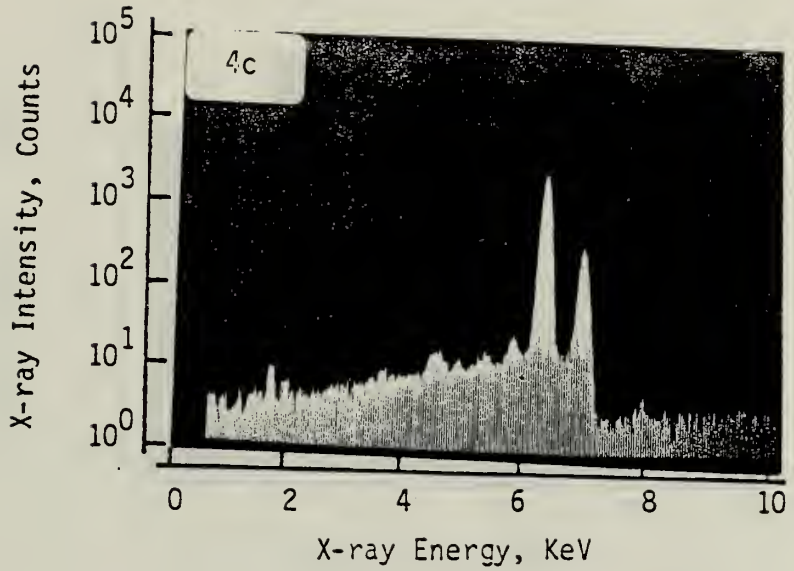
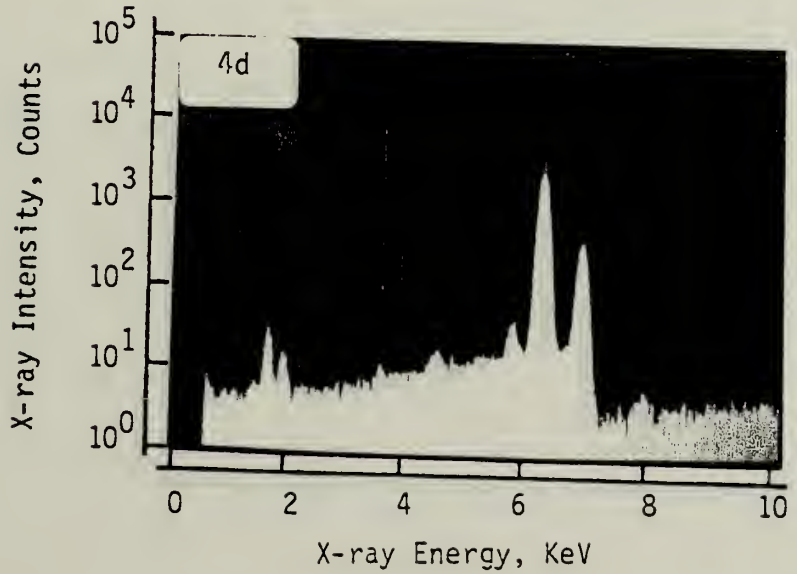
Figure 4c&d. XES Microanalysis Spectra from Piece A (Please see Figure 3a)

(c) Light Areas of Slag (At Point R)

(d) Dark Areas of Slag (At Point S)

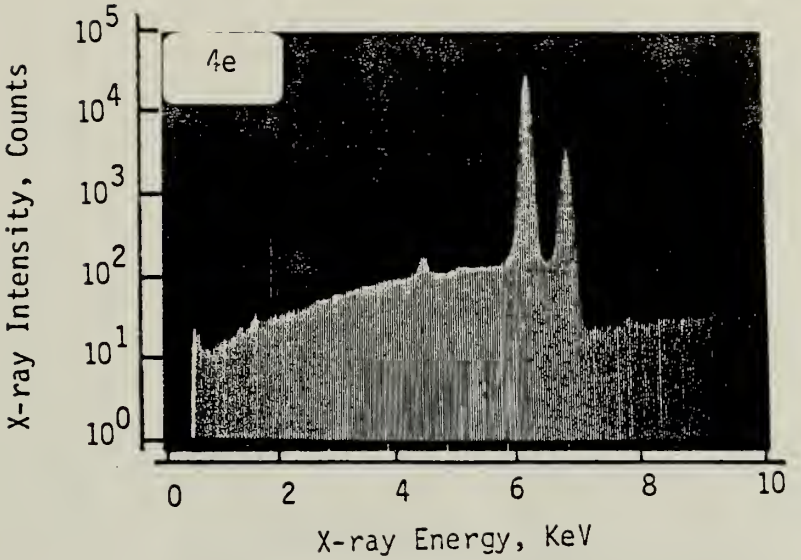
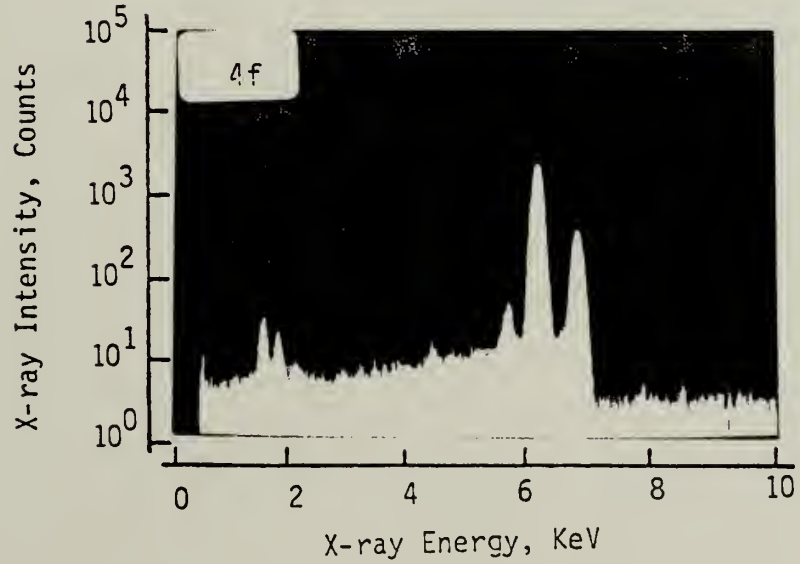
Figure 4 e&f. XES Microanalysis Spectra from Piece B (Please see Figure 3b)
(e) Matrix (At Point X)
(f) Slag (At Point Y)

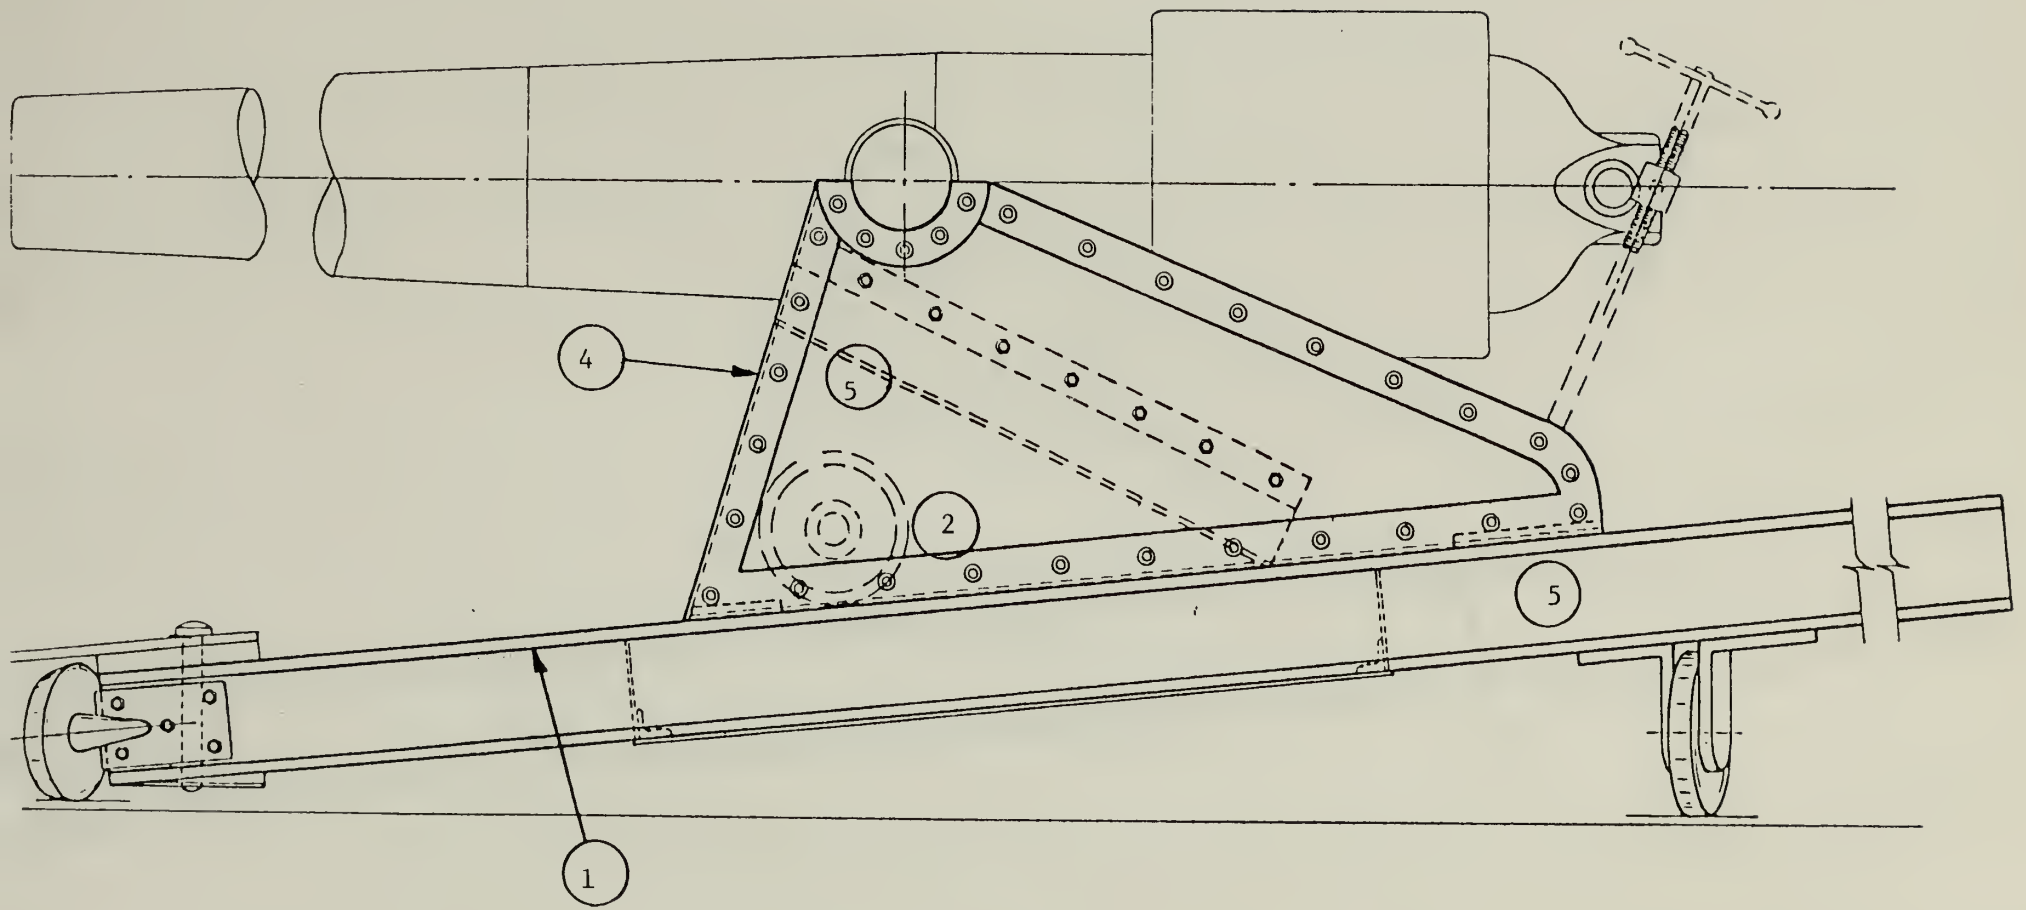
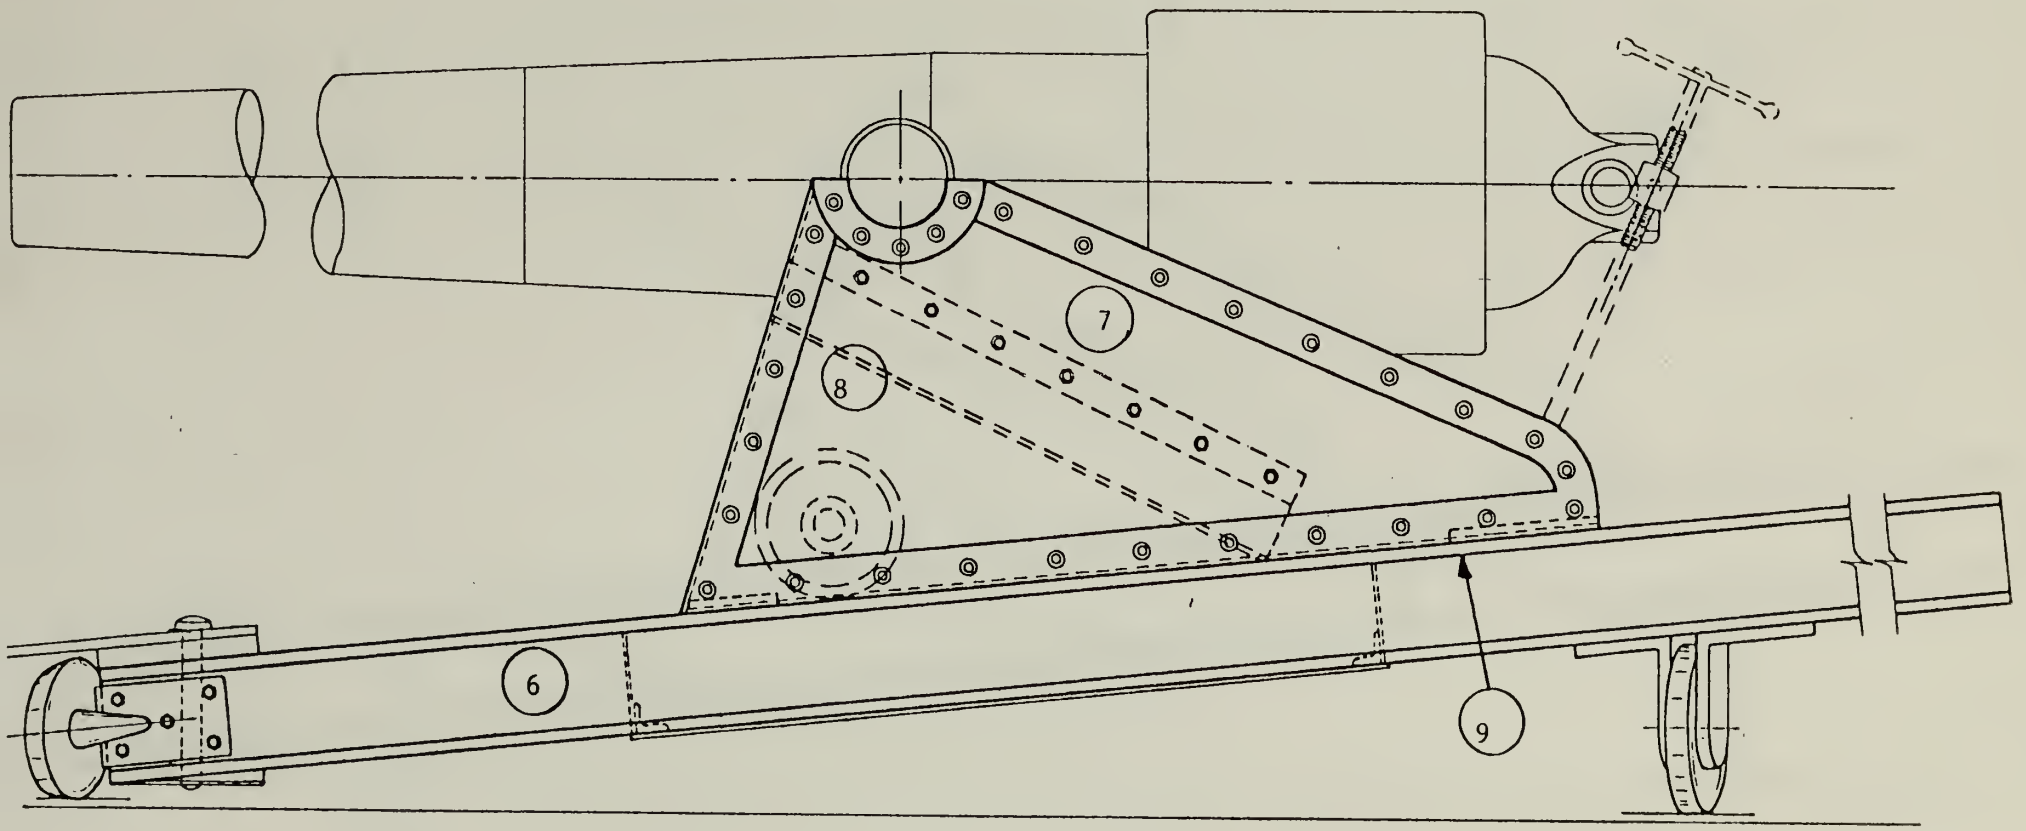
Cannon Number One

Cannon Number	Remarks
#1 (For film location refer to enclosed sketches)	1) View 1 revealed crack indication as marked on radiograph. 2) View 7 & 8 revealed several areas of excessive corrosion (as marked) that appear to be thru the metal.
#2 (For film locations refer to enclosed sketches)	1) General condition reveals corrosion & rust throughout entire inspection area. 2) View 3 reveals 2 areas of heavy corrosion as marked on radiographs.
#3 (For film locations refer to enclosed sketches)	1) View 1 indicates possible minor cracking as marked on radiographs. 2) View 8 reveals cracking beginning in parent metal around bolted connection as marked on radiographs. No other apparent effects noted.
